2023 PAG Meeting

Northern Maine Transmission System Chapter 330 Work Plan Map

Chapter 330 Plans & Adjustments

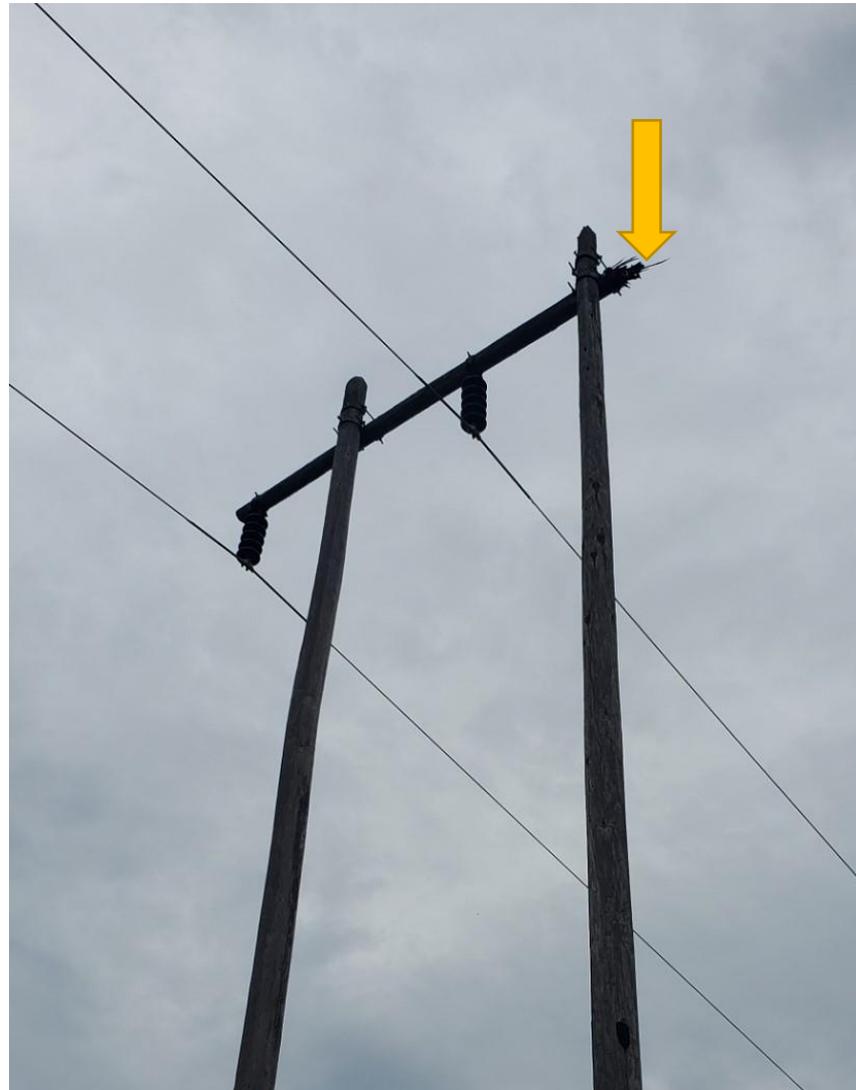
Line 6905 Condition

Wood pole
crossarm
failure due to
internal decay
or possible
lightning strike

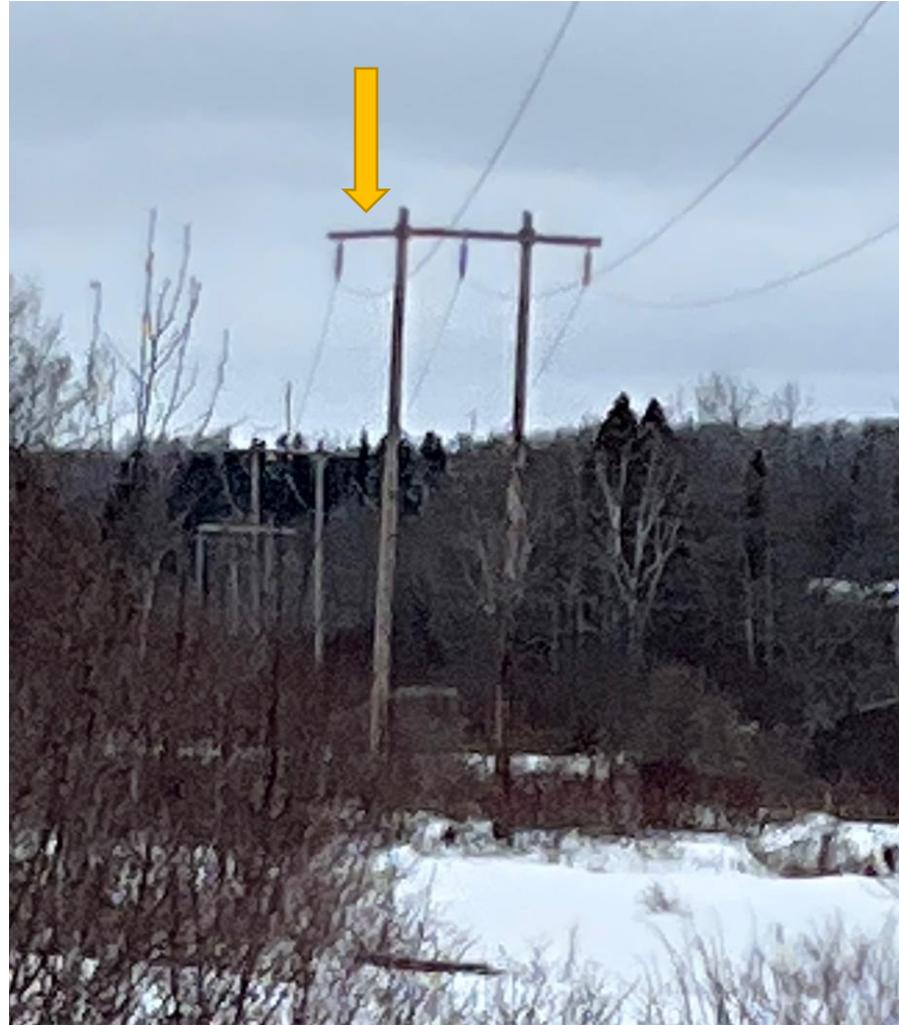
Line 6905 Condition continued...

**Drooping
crossarm
under
weigh of
conductors
likely
caused by
internal
decay**

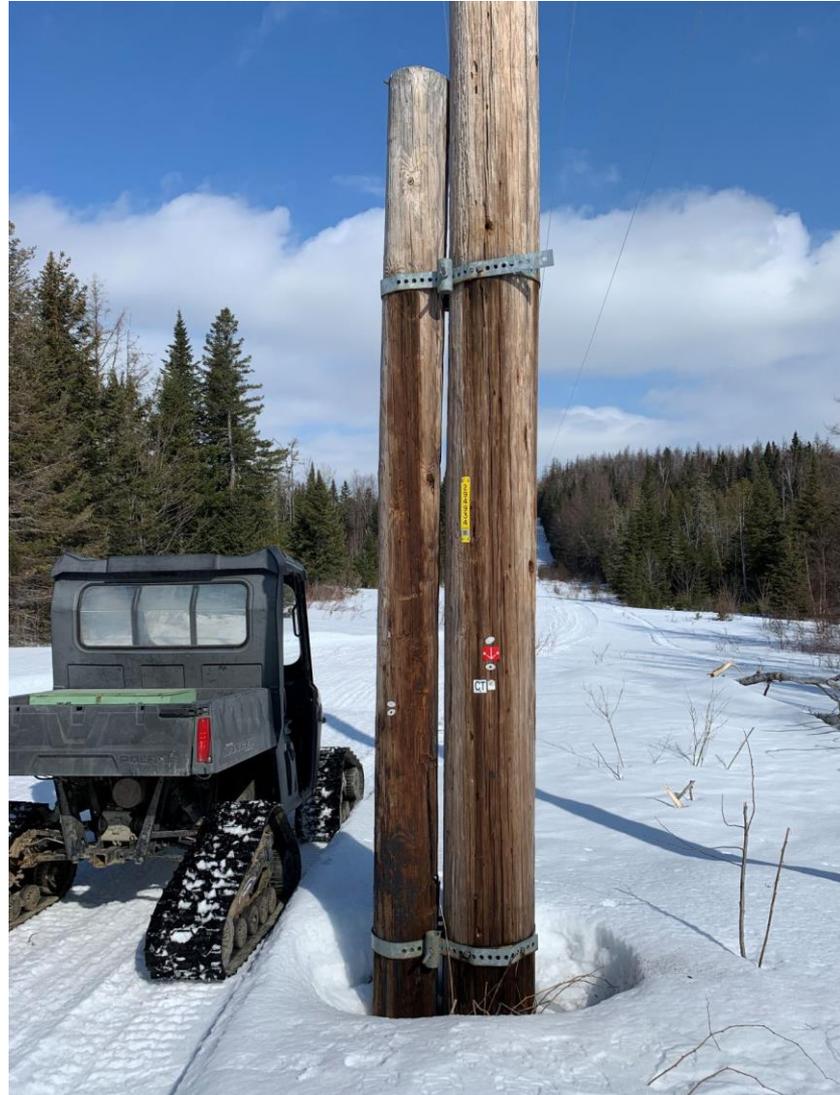
Line 6905 Condition continued...

Company inspectors are finding that wood stub poles placed alongside original wood poles with decay are themselves reaching end of life leading to structure replacement

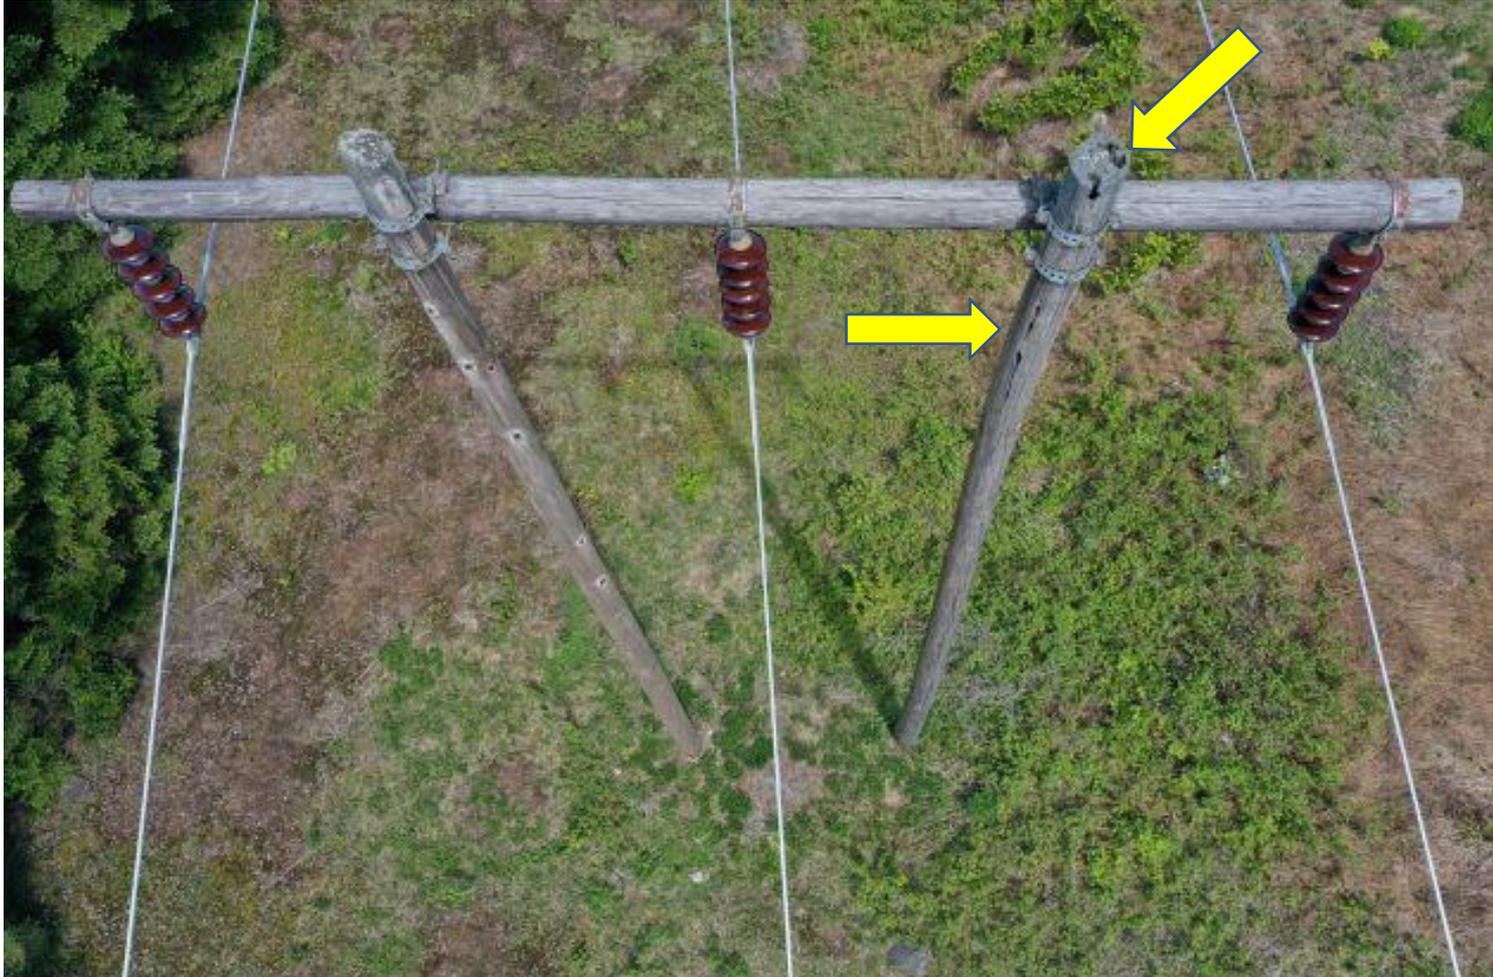
Line 6920 Condition

- **Line 6920 – Line connects Mars Hill Switching Station to Mullen Substation serving communities of Bridgewater and Monticello via tap lines. Originally built in 1964 through 1967 period, wood poles and wood pole crossarms continue to age and become weaker with more rejects expected to occur in coming years. Eventually, a complete rebuild of various sections will make more economic sense than spot targeted maintenance work. Also, lack of overhead lightning protection places many structures at risk of strikes, which can adversely impact crossarms, poles and insulators.**

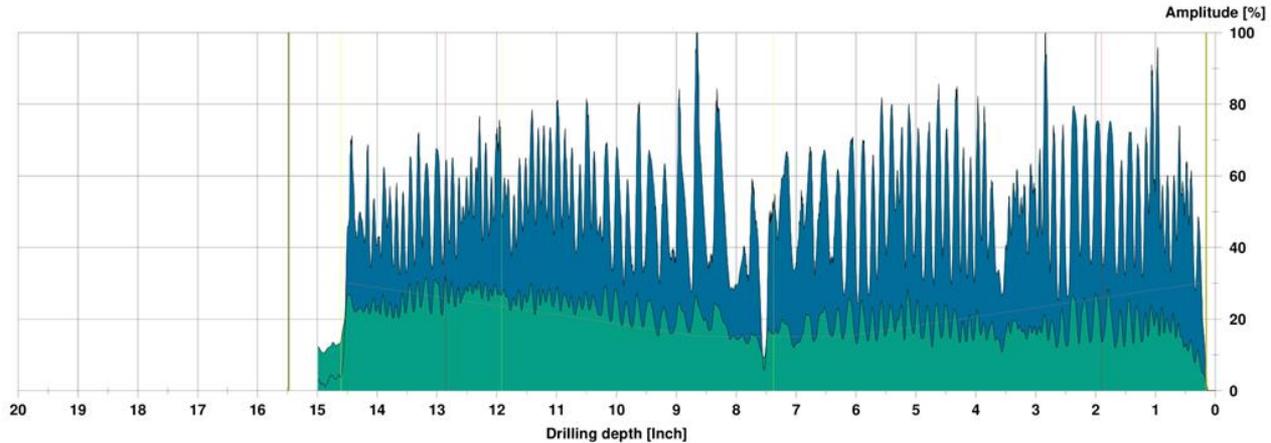
20694M047 (PASS).rgp

Resistograph Plot - Wood Pole in good condition

Program	: Pole - EMERA 1.00	Sum decay	: 0,0% 0,0% 0,0%
Pole type	:	Heart rot	: 0,0% 0,0% 0,0%
Measurement	: Below soil level	Shell rot	: No No
Defect pattern	: No decay	Remaining wall	: 50,0% 50,0% 50,0%
Result (auto)	: PASS	Strength	: 100,0% 100,0% 100,0%

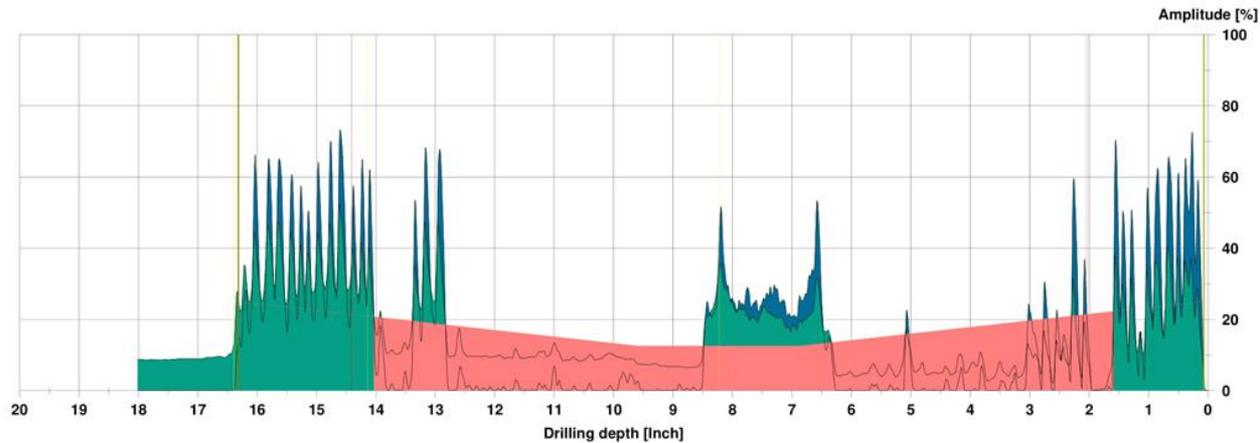
20781M013 (REJECT).rgp

Rejected Wood Pole – Heart Rot

Program :	Pole - EMERA 1.00	Sum decay :	40,7%	35,6%	76,3%
Pole type :		Heart rot :	40,7%	35,6%	76,3%
Measurement :	Auto diameter	Shell rot :	No	No	
Defect pattern:	Heart rot	Remaining wall:	9,3%	14,4%	11,8%
Result (auto) :	REJECT	Strength :	56,1%	74,3%	65,2%

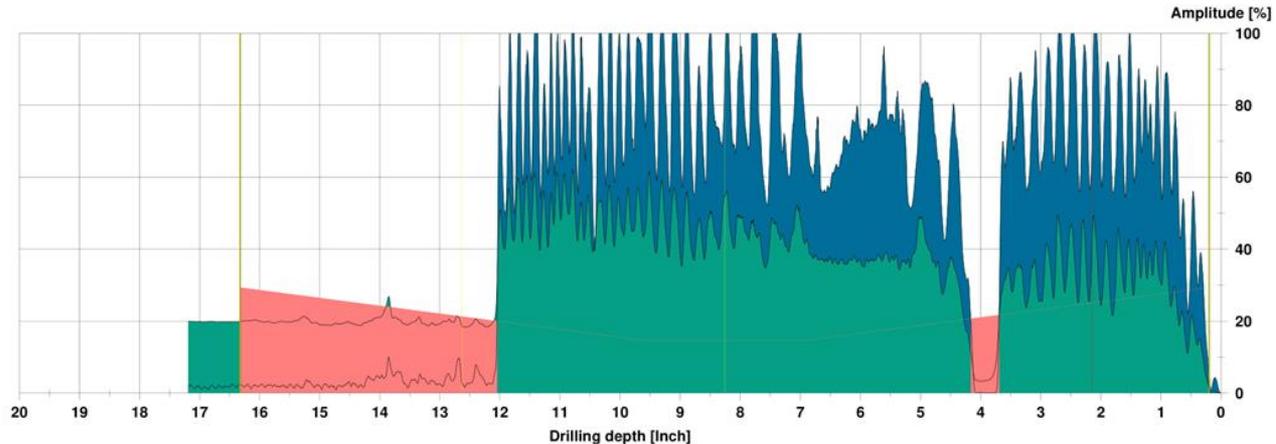
20705M046 (REJECT).rgp

Rejected Wood Pole – Heart Rot & Shell Rot

Program :	Pole - EMERA 1.00	Sum decay :	2,9% 0,0% 2,9%
Pole type :		Heart rot :	2,9% 0,0% 2,9%
Measurement :	Below soil level	Shell rot :	No Yes
Defect pattern:	Heart+shell rot	Remaining wall:	21,7% ---
Result (auto) :	REJECT	Strength :	89,7% ---

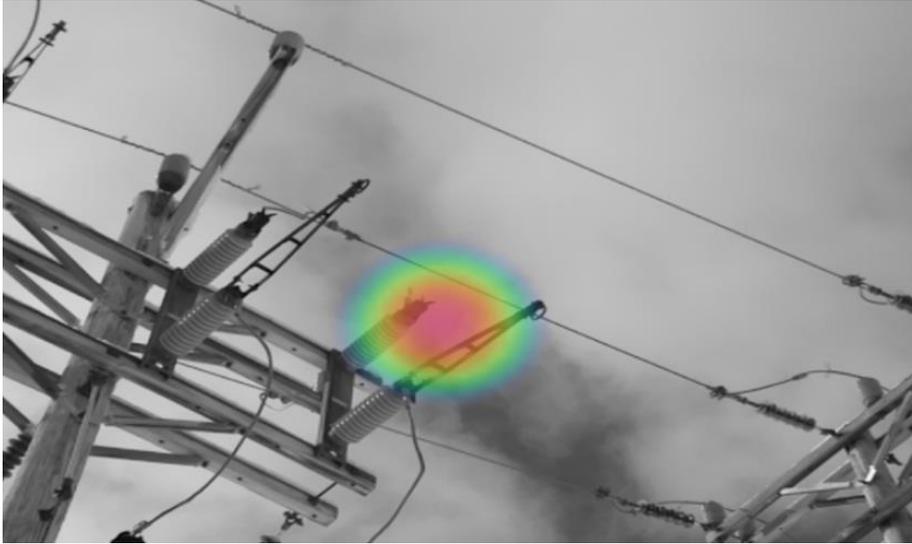
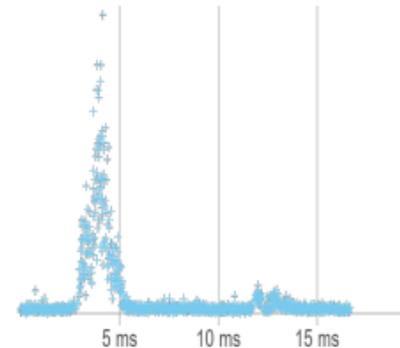
This is classified as corona, i.e., partial discharge into air. In most cases, corona is harmless.

Typically no action required unless power loss, audible noise, electromagnetic interference, or deterioration of nearby polymer insulators is a problem.

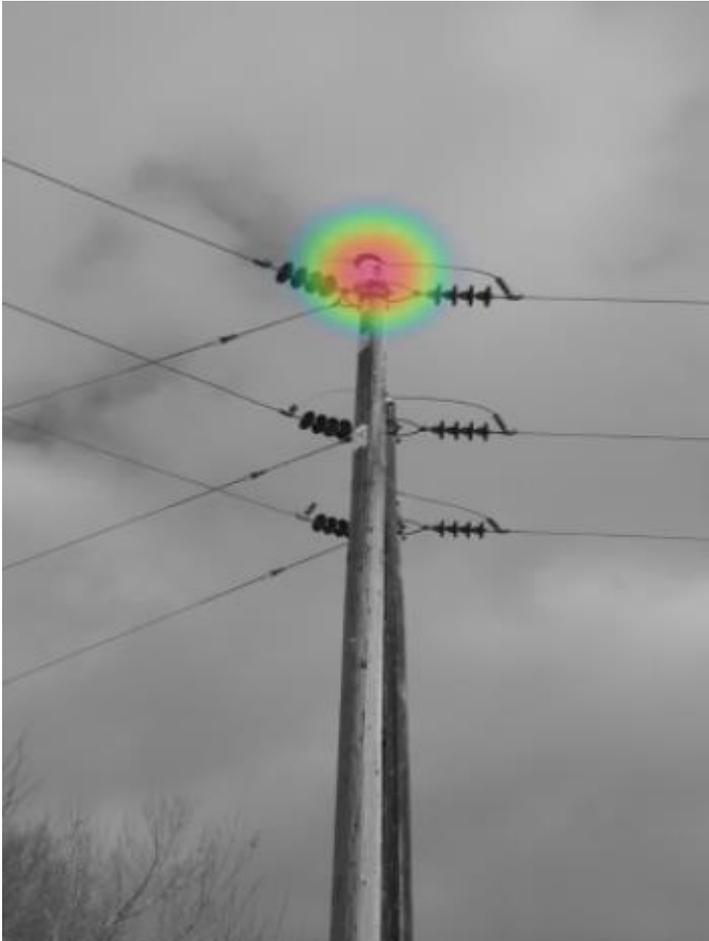
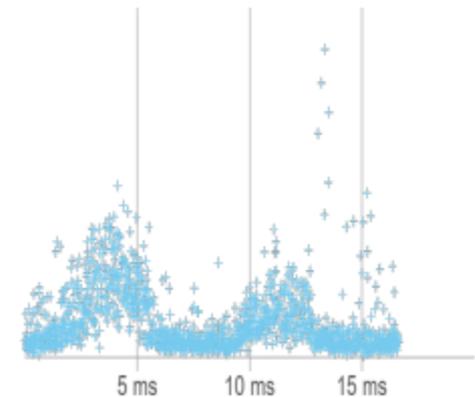
This is classified as a surface or internal discharge. The discharge appears to be strong and might rapidly escalate to complete insulation breakdown.

Immediate action. Visual inspection. Cleaning of polluted surfaces. Repair or replacement of the components.
