2023 PAG Meeting

Northern Maine Transmission System Chapter 330 Work Plan Map

Chapter 330 Plans & Adjustments

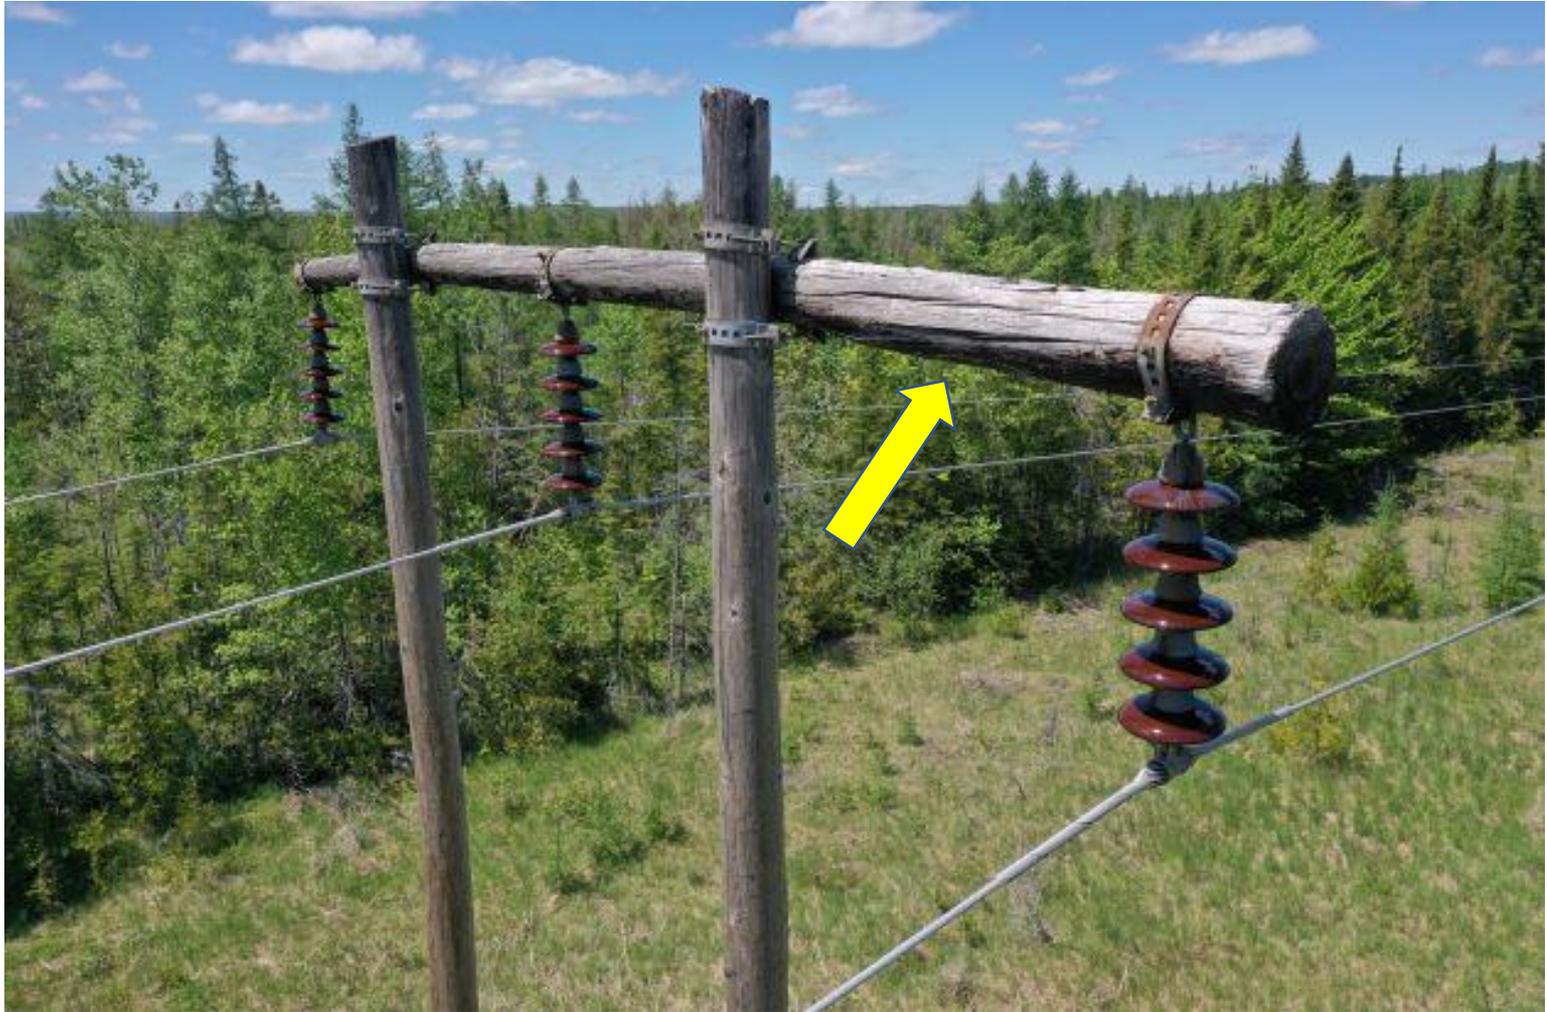
Line 6920 Condition continued...

- **Line 6920 – Line connects Mars Hill Switching Station to Mullen Substation serving communities of Bridgewater and Monticello via tap lines. Originally built in 1964 through 1967 period, wood poles and wood pole crossarms continue to age and become weaker with more rejects expected to occur in coming years. Eventually, a complete rebuild of various sections will make more economic sense than spot targeted maintenance work. Also, lack of overhead lightning protection places many structures at risk of strikes, which can adversely impact crossarms, poles and insulators.**

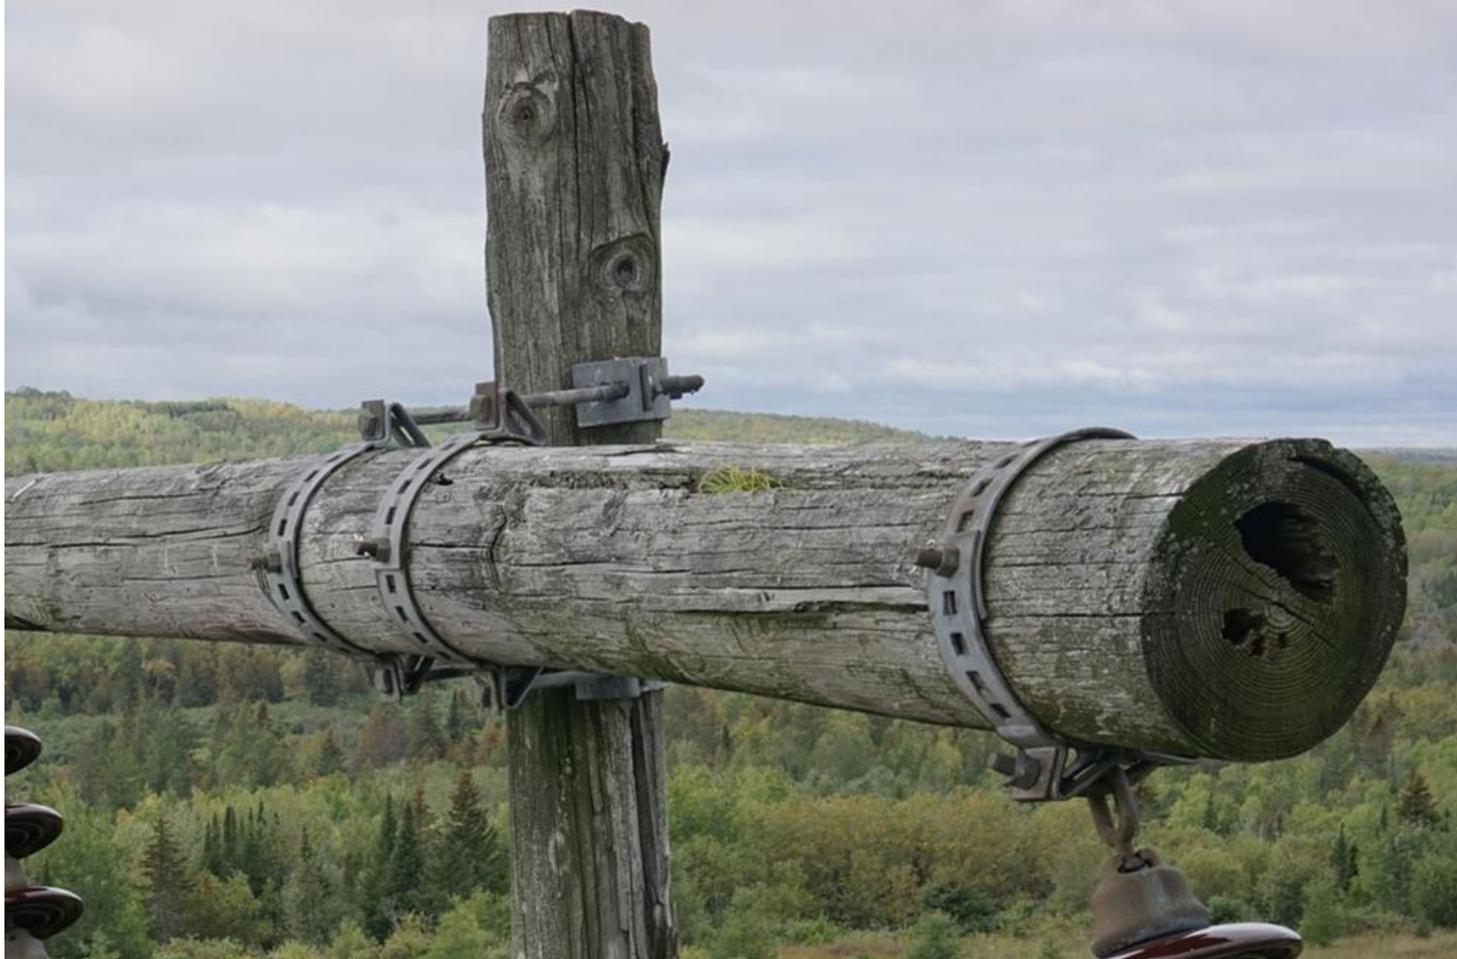
Example of a Closeup Drone Inspection Photo

Overhead images provided by drones are providing asset managers with a new and different way of assessing asset condition

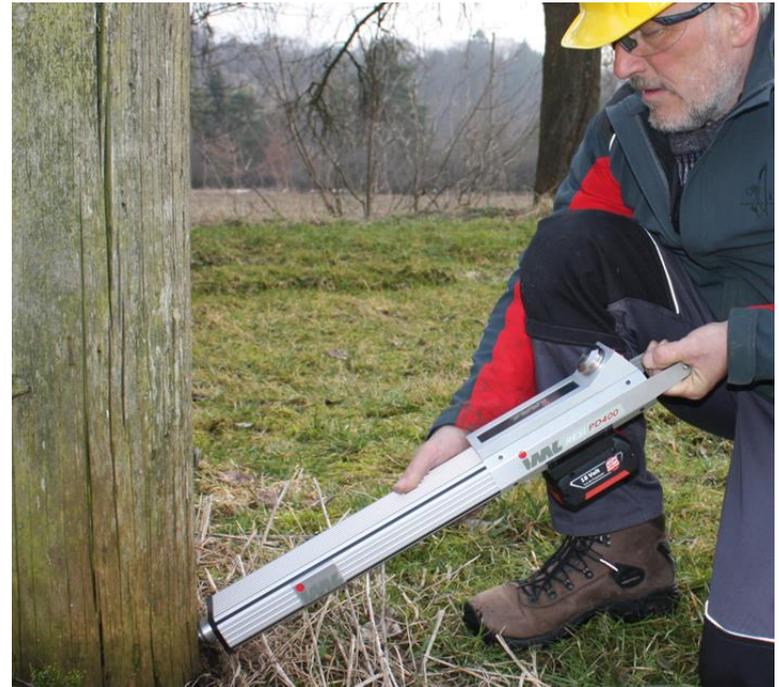
Using a long thin needle the electric power consumption of the resistograph drilling device is measured and recorded. The resistance data gathered provides a high linear correlation between the measured values and the density of the penetrated wood.
